west virginia department of environmental protection

**CONSENT ORDER  
ISSUED UNDER THE  
WATER POLLUTION CONTROL ACT  
WEST VIRGINIA CODE, CHAPTER 22, ARTICLE 11**

TO: MarkWest Liberty Midstream & Resources, L.L.C.      DATE: March 28, 2019  
Gregory Bezdek, SVP, NE Region  
4600 J Barry Ct. Ste 500  
Canonsburg, PA 15317      ORDER NO.: 8945

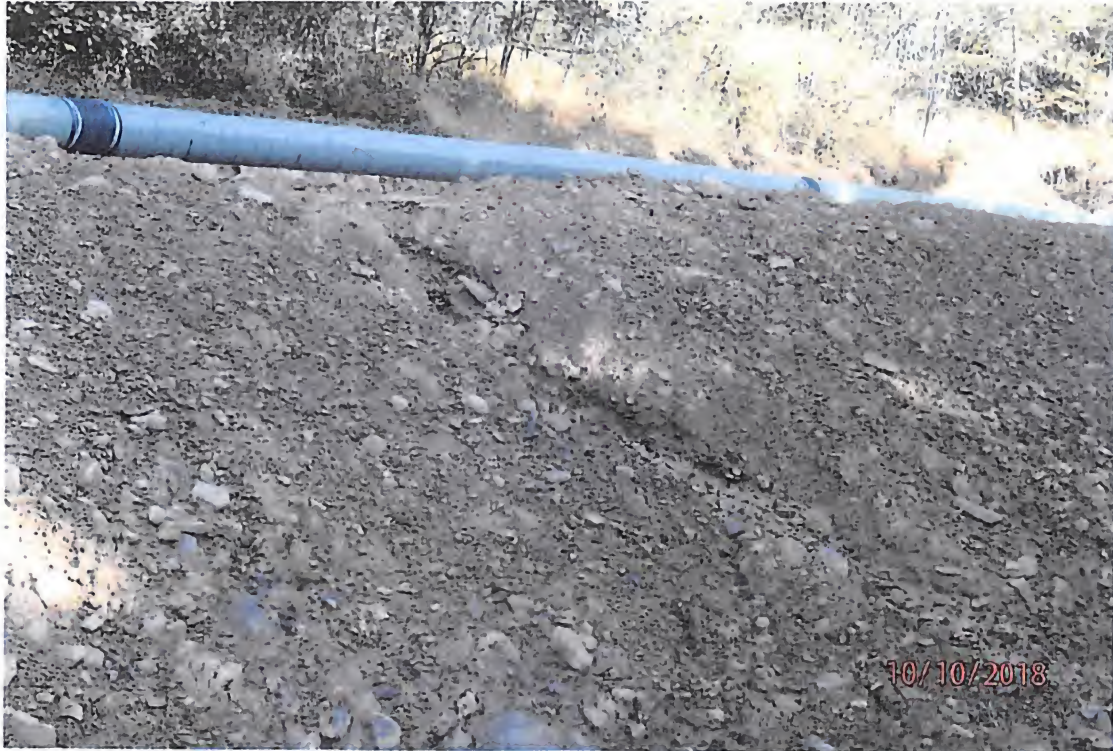
Offsite CNA deposits in UNT Morgans Run (39°17.506' X 80°40.813') as a result of the previously pictured deficiencies.
